Confidential Home Inspection Report

555 Cardinal Drive
Colorado Springs, CO, 80951

Inspection ID: Sample Report
Date: January 1, 2009

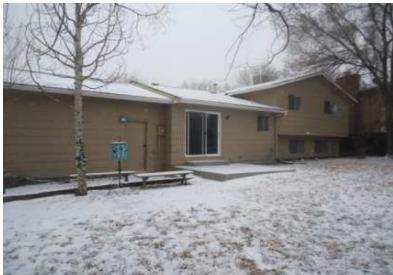
The slope away from the foundation is sufficient in all areas. The property landscaping could not be seen due to snow coverage. No drainage problems appeared to be present. No repairs or maintenance needed could be seen at the time of inspection.

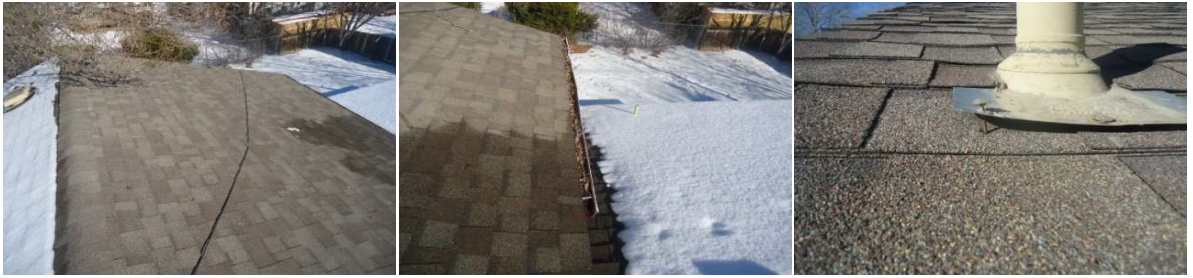
The roofing is a 30 year dimensional shingle and is in good condition. Only 50% of the roofing could be seen due to snow coverage. The gutters are in fair condition, but are full of leaves and debris. The gutters need to be cleaned. The flashing to the vent stacks have come loose in multiple places. The flashing needs to be securely nailed to the roof and sealed.

24. The self flashing to multiple vent stacks has come loose from the roof. The flashing needs to be nailed down securely and sealed.
25. The chimney should have a cap and screen installed to prevent water and animal intrusion.

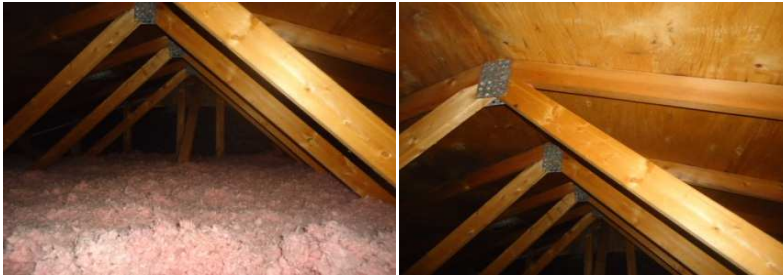
The attic is access through a door in 2nd floor ceiling. The attic is composed of pre-fabricated roof trusses, plywood roof sheathing, and fiberglass insulation. No signs of moisture or previous moisture damage are present. No repairs or maintenance needed were found at the time of inspection.

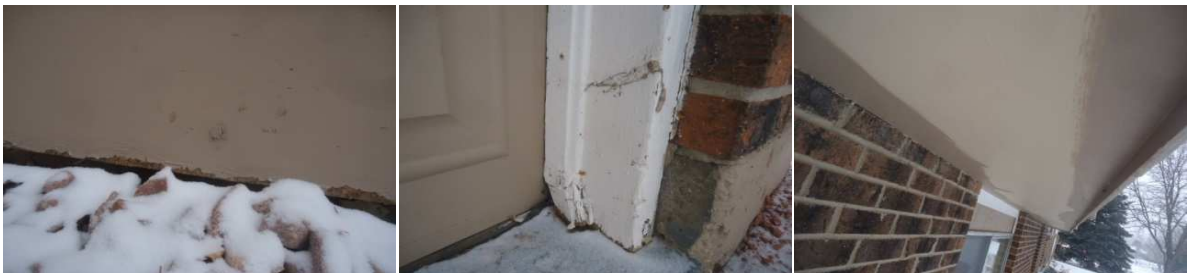
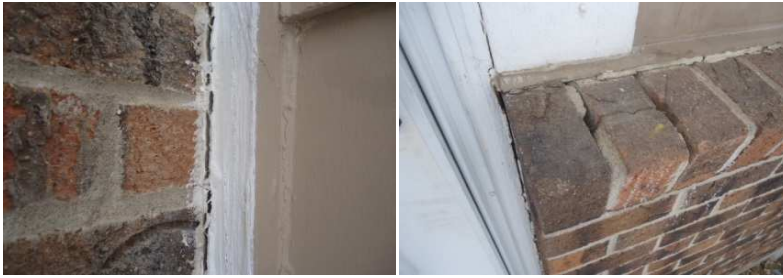
Exterior Walls - The siding to the property is hardboard and is in good condition. Minimal peeling paint is present at the base pieces of the siding. No major swelling of the hardboard is present. The trim/framing along the edge of the garage door has water damage present. The trim should be repaired. The under side of the front overhand was only partially painted. The painting needs to be finished. The corner between the siding and the brick chimney needs to be re-caulked. The bricks to the right of the front door are loose and need to be re-installed securely.

1. The bricks to the right of the front door are coming loose and need to be installed securely.
2. The corners between the siding and the brick chimney need to be re-caulked.

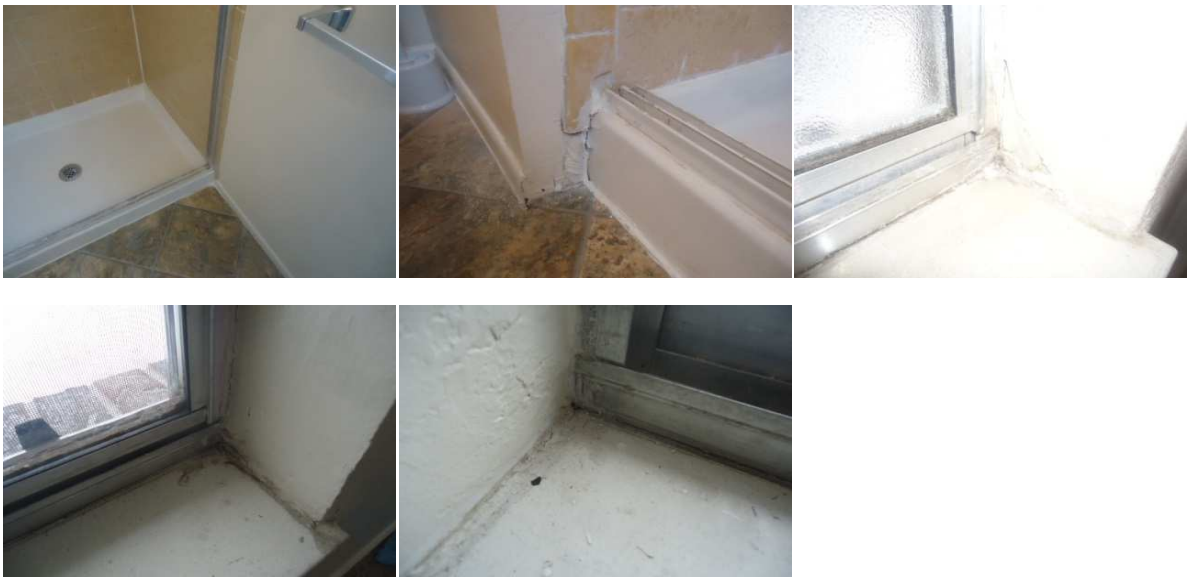
Interior Walls - The majority of the interior walls are in good condition. No major damage or deficiencies were found during the inspection. The bottom tiles in the master bathroom shower are missing at the edges. The tiles should be replaced. The drywall in the basement was finished poorly. Drywall seams are easily seen. All window sills in the house have drywall damage at the corners and need to be re-caulked.

11. The interior edges of all window sills have drywall damage present. The drywall damage should be patched and the interior edges of the windows should be re-caulked.

14. The tiles at the base of the master bathroom shower are missing. The tiles should be replaced.
15. The kitchen faucet and sprayer are not working properly. The faucet needs to be replaced.

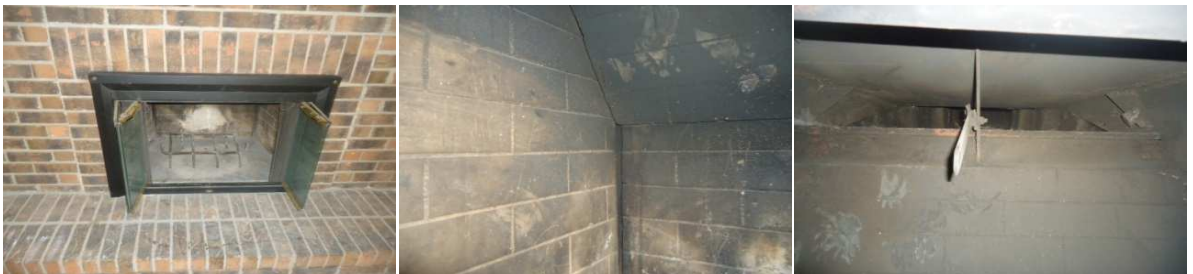
The fireplace is a gas unit that has been converted back to a wood burning fire place. The back corners of the fireplace have gaps present and should be sealed with mortar. The chimney has a build up of soot present and needs to be cleaned.

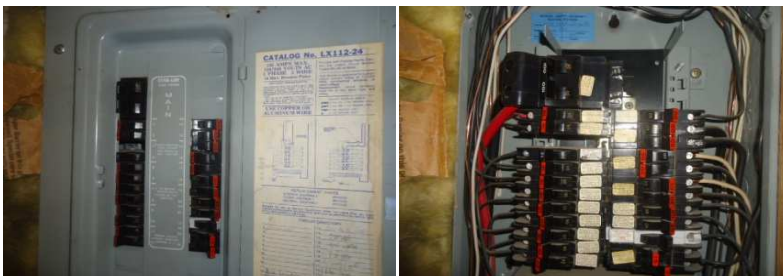
The electrical panel is a 100 amp Federal Pacific unit located in the garage. Federal Pacific electrical panels have been classified as a fire hazard. The panel has had 2 breakers already replaced. The electrical panel needs to be further tested by a licensed electrician to ensure that it is working safely and properly. Replacement of the panel may be needed.

10. The electrical panel is a Federal Pacific unit. These panels have been classified as a fire hazard. This particular panel has already had 2 breakers replaced. The panel needs to be further tested by a licensed electrician to ensure that it is working safely and properly. Replacement may be needed.

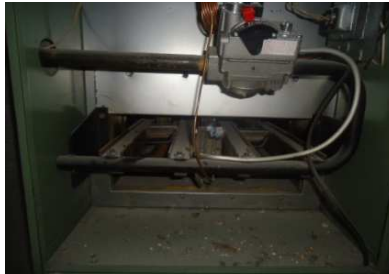
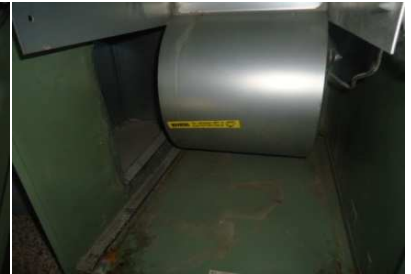
The furnace is and older Magic Chef unit. Rust and corrosion is building in the furnace. The furnace is very dirty and is missing the filter. Magic Chef furnaces are common for having cracked heat exchangers. The furnace needs to be cleaned, serviced, and certified by a licensed hvac technician. Any further repairs, maintenance, or possible replacement deemed necessary by an hvac technician should be performed.

7. The furnace is an older Magic Chef unit. These units commonly have cracks along the heat exchanger. Rust and corrosion is present in this furnace. The furnace is also very dirty and is missing the filter. The furnace needs to be cleaned, serviced, and certified by a licensed hvac technician.

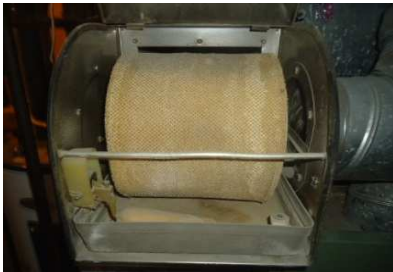
The humidifier is in poor condition. The interior of the humidifier has corroded. The humidifier needs to be serviced, and should be replaced.

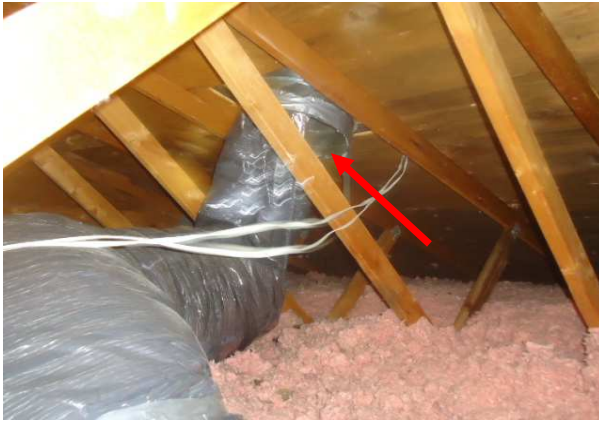
The swamp cooler could only be partially inspected during the inspection. The vent for the swamp cooler is falling of the swamp cooler itself. The swamp cooler needs to be repaired and serviced.

16. The ice maker to the refrigerator is not working. The ice maker should be repaired.
17. The venting for the swamp cooler is not attached to the swamp cooler inside the attic. The venting from the swamp cooler to the house needs to be repaired.

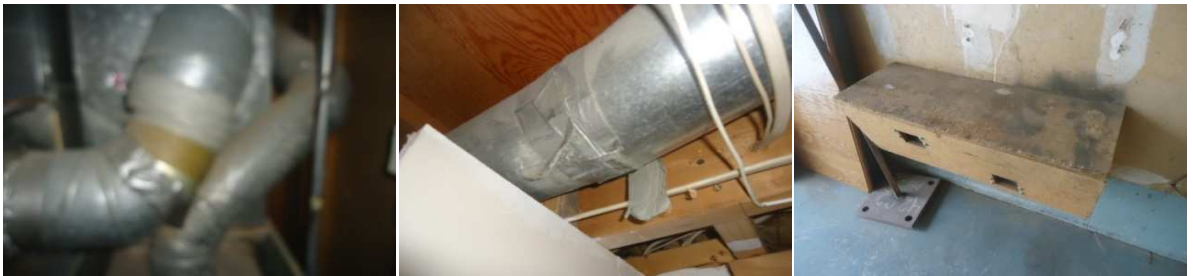
The duct work and vents coming out of the furnace are in marginal condition. The duct tape at the joints is falling apart. The vent for the humidifier is too close to the vent for the furnace. The vent is only single walled. The joints to the vent pipes need to be repaired with metal tape. Heat registries have been installed in the garage that were not built to code. The heat registries need to be properly installed according to building code, or outright removed.

8. The venting and the duct work coming out of the furnace has the tape falling apart at the joints. The venting is also single wall. The venting should be repaired with metal tape at the joints.

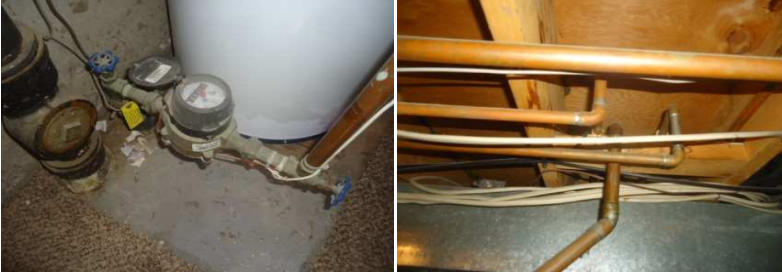
The main water shut off valve is located in the basement. A water meter and pressure regulator are present. The water lines throughout the house are copper and are in good condition. No leaks could be seen. No repairs or maintenance needed to the water lines were found during the inspection.

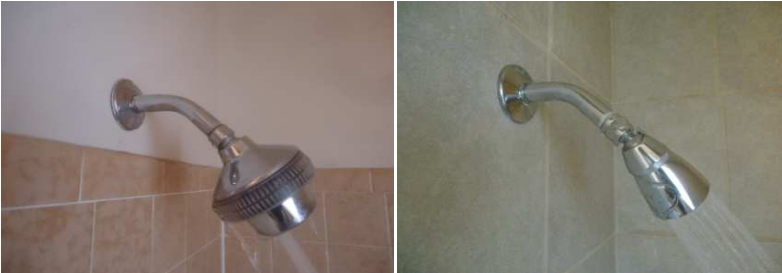
The shower heads in the master bathroom and basement bathroom leak at the connections to the water line. The shower heads need to be re-installed with new plumbers tape.

12. The shower heads in the master bathroom and the lower level bathroom are leaking at the connections to the water lines. The shower heads should be repaired.

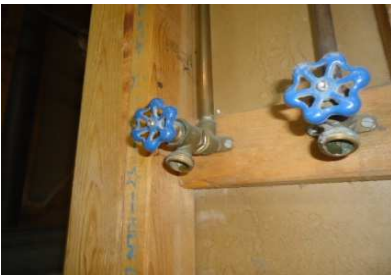
The left water valve to the washing machine has a slight leak. The water valve should be replaced.

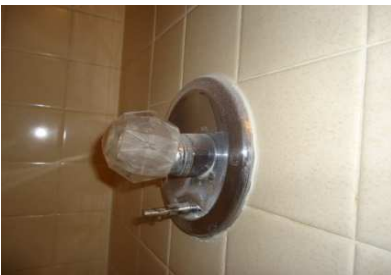
The bathtub faucet leaks from the base of the handle in the 2nd floor hallway bathroom. The handle needs to be replaced.

13. The water faucet handle to the hallway bathtub is leaking at the base of the handle. The handle needs to be repaired or replaced.

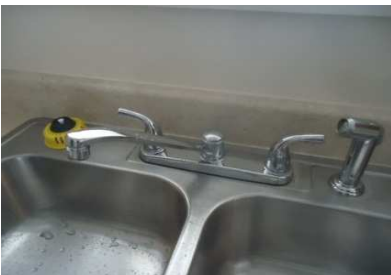
The kitchen faucet is not working properly. When the sprayer to the faucet is used, the valve sticks and does not allow water back to the faucet when the sprayer is turned off. The faucet and sprayer need to be repaired or replaced.

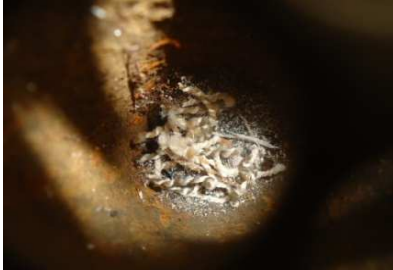
Each of the drains throughout the house were tested and are in good condition. Each drains allowed water to drain freely. No leaks are were found. The floor drain in the basement next to the hot water heater appears to be clogged. The drain needs to be cleaned. Due to the age of the home, it is recommended to have the main drain line from the house to the city line in the street scoped and cleaned if necessary.

20. The door leading from the garage to the back yard has air gaps present. New weather stripping needs to be installed.
21. Due to the age of the home, it is recommended to have the drain line from the house to the main city line in the street scoped and cleaned if necessary.

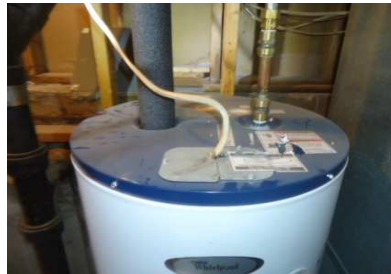
The hot water heater is an electric unit located in the basement. No rust or corrosion could be seen within the unit. The TPR valve is in good condition. No repairs or maintenance needed were found at the time of inspection.

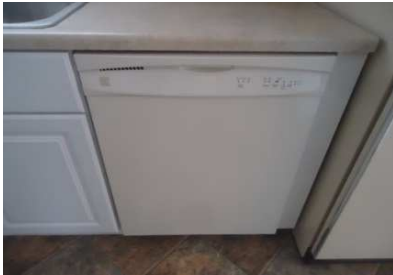
The dishwasher is an older unit, but was tested and is working properly. No repairs or maintenance needed were found at the time of inspection.

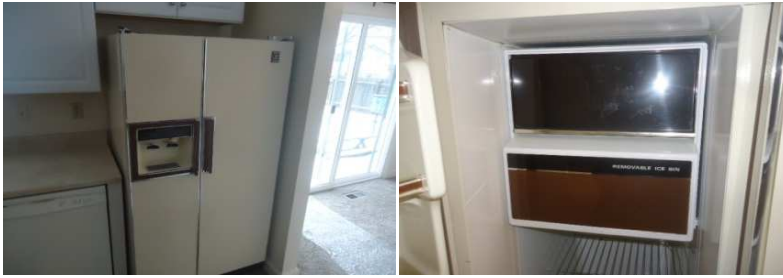
The refrigerator is an older unit and is in marginal condition. The refrigerator and freezer both appear to be cooling properly. The water line works properly. The ice maker is not working and should be repaired.

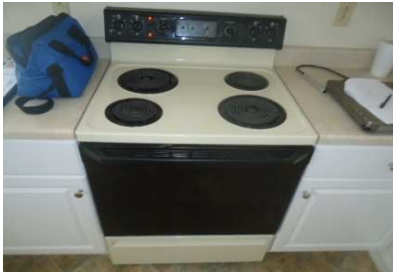
The stove is an older unit, but is in good condition. Each of the burners were tested and are working properly. The oven heats properly. No repairs or maintenance needed were found at the time of inspection.

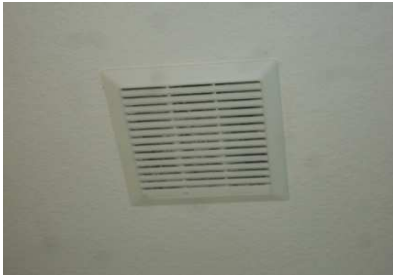
The exhaust fans in each of the bathrooms are in good condition. Each of the fans were tested and are working properly. No repairs or maintenance needed were found at the time of inspection.

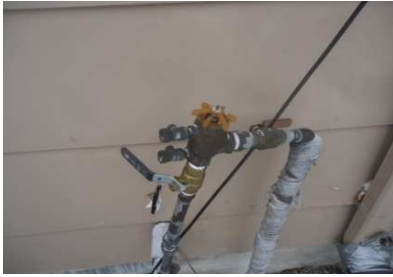
A sprinkler system is present, but could not be tested during the inspection. The top, bell cover to the backflow preventer is missing. The backflow preventer should be repaired or replaced. Due to snow coverage, the sprinkler valves and heads could not be inspected.
